TEST REPORT

COMPETITORS PACKERS RETURNED TO RIPE FOR REBUILD

REPLACEMENT INFLATABLE PACKERS AND ELEMENTS PTY LTD

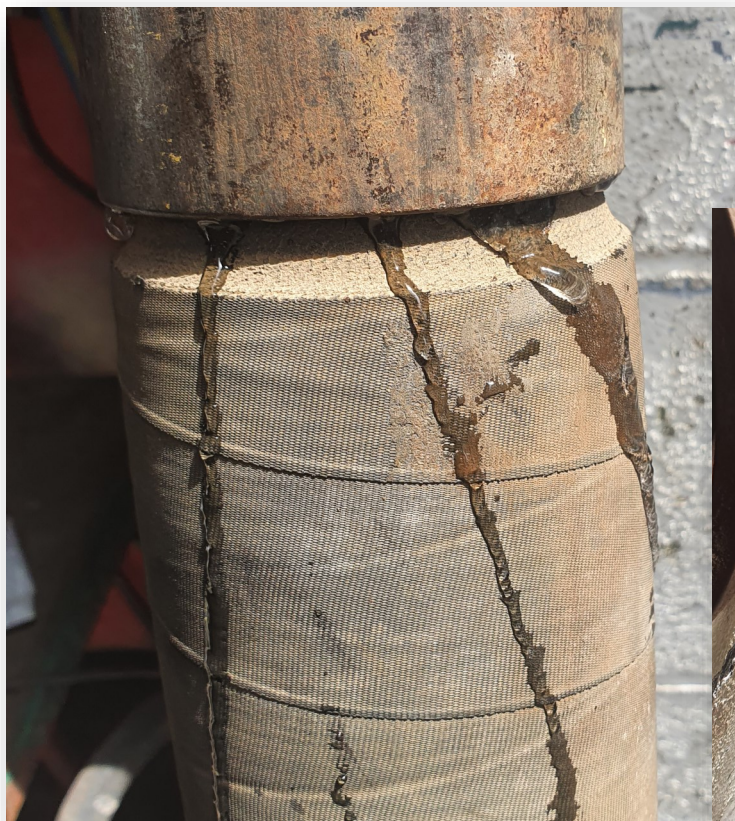
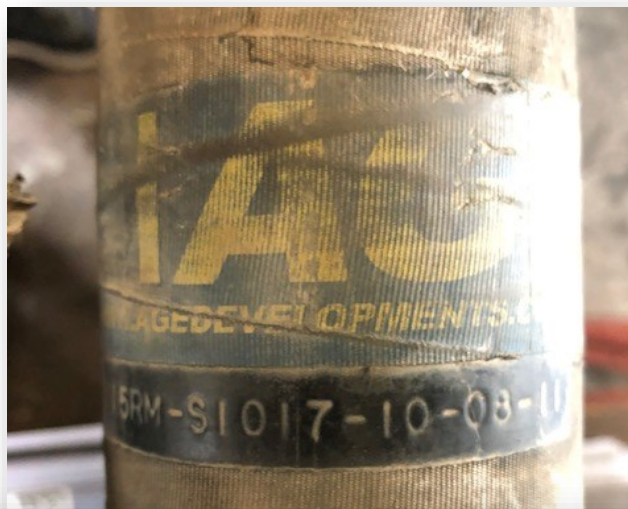
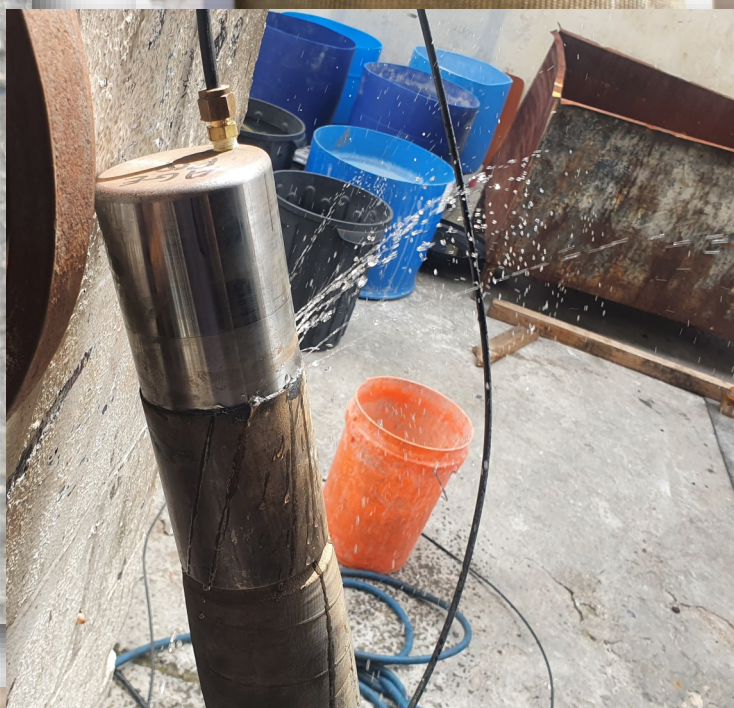
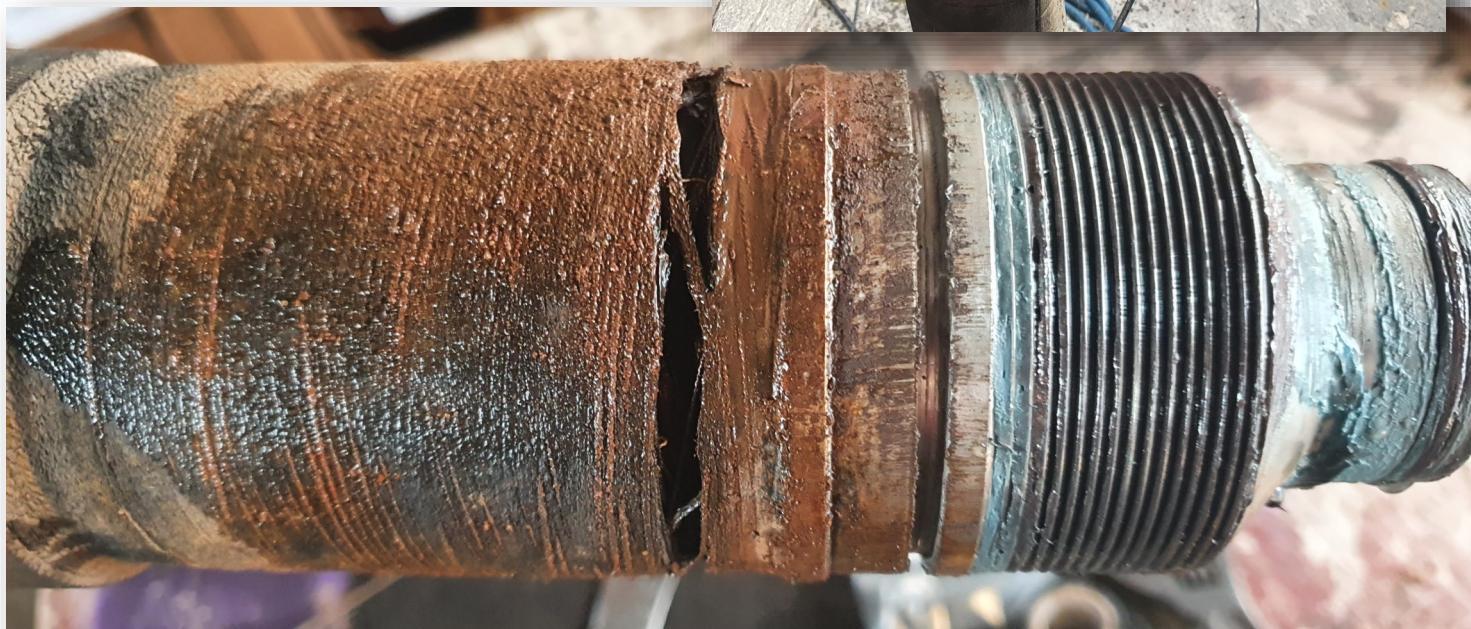
PQ PACKER Ø80 (115RM—S1017 / 10-08-11)

Comments: Failed vulcanising under ferrules on initial inflation.

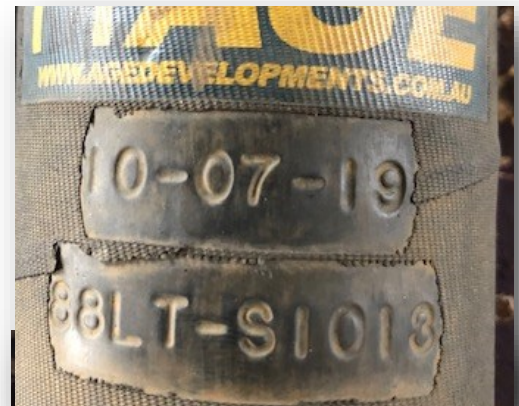
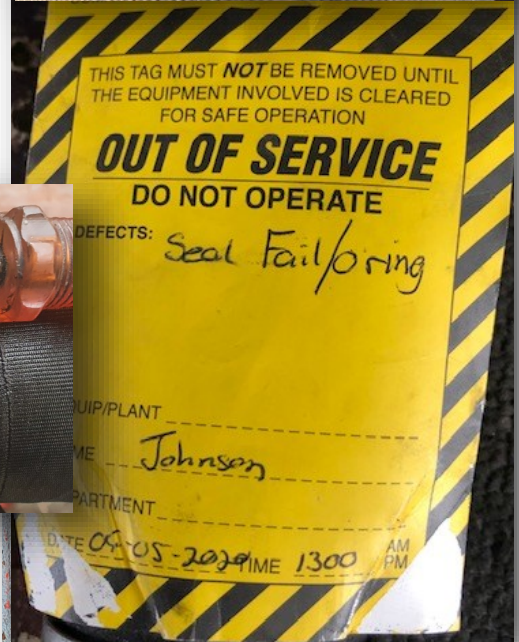
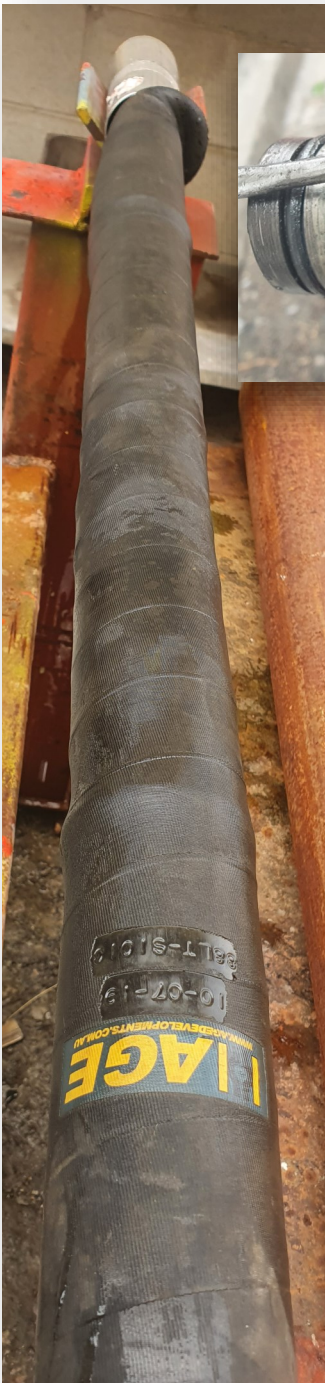
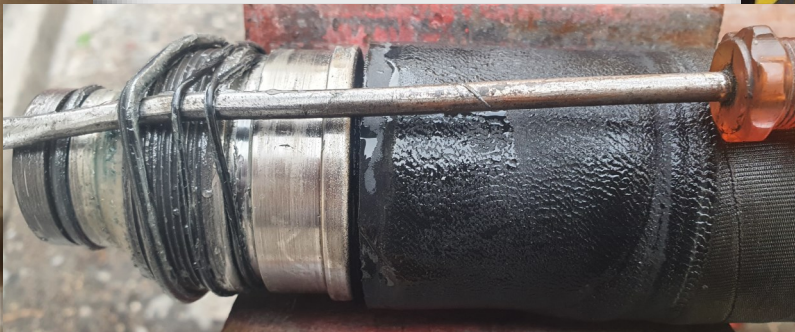
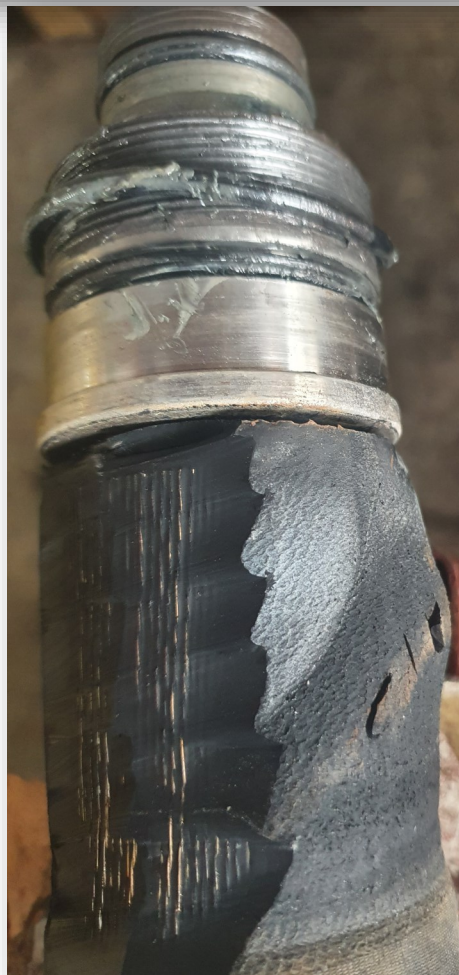
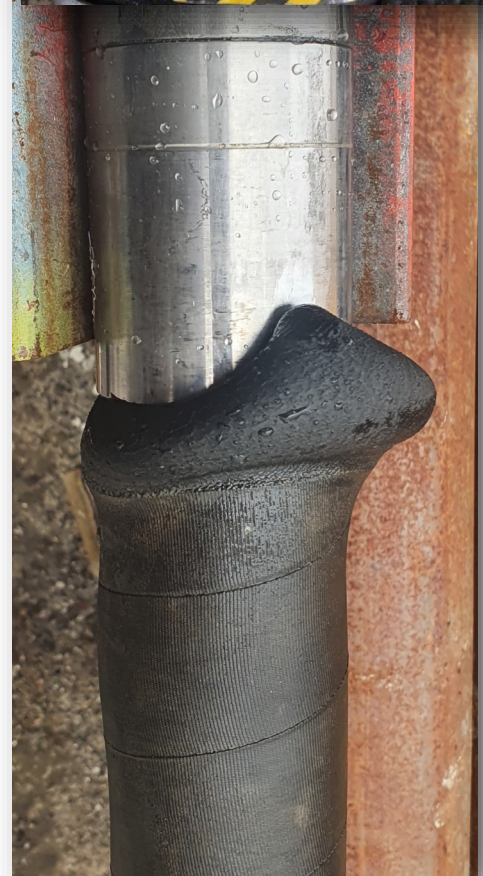
HQ PACKER Ø60 (88LT-S1013 / 10-07-19)

Defects: Seal Fail/O-ring

Comments: Failed vulcanising under ferrules on initial inflation.

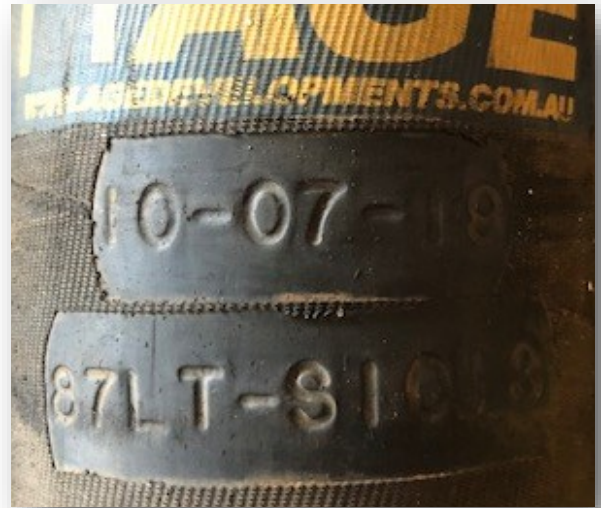
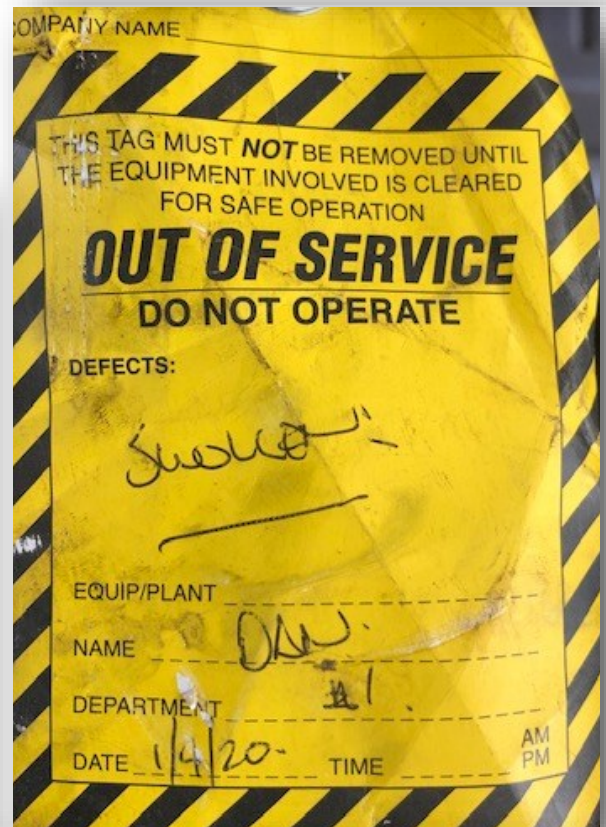
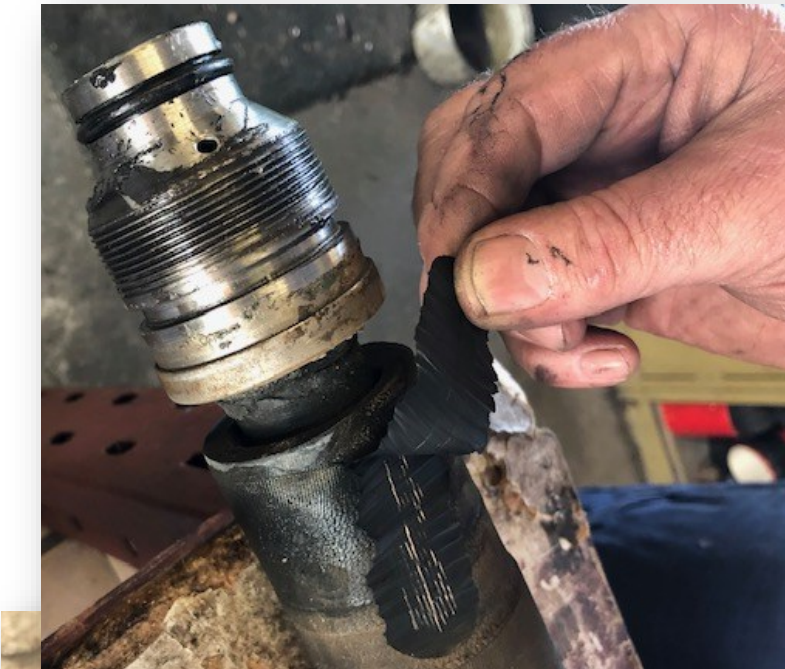
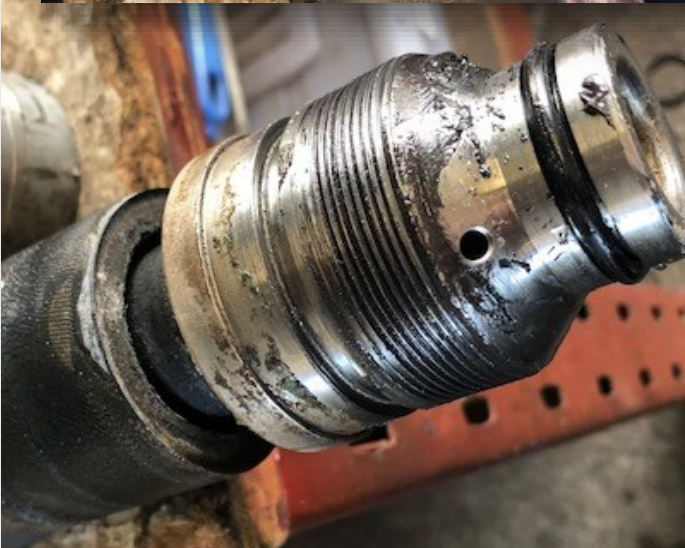
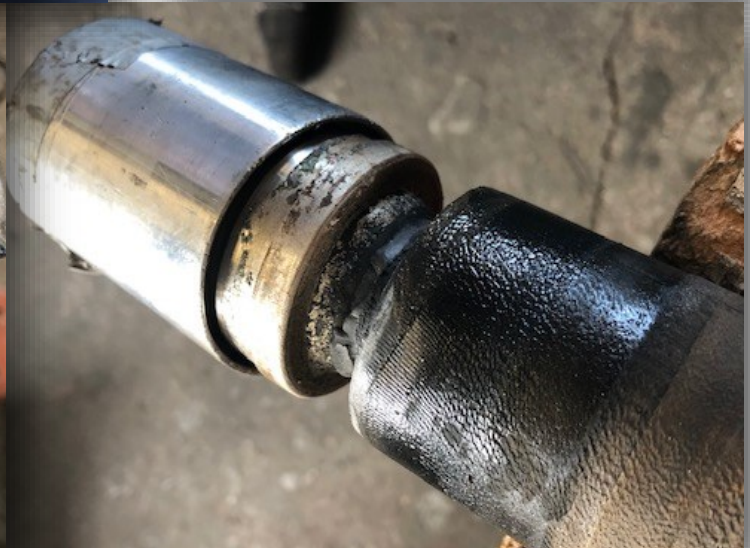
HQ PACKER Ø60 (87LT-S1013 / 10-07-19)

Defects: Swollen

Comments: Failed on third inflation at 700psi in Ø96mm hole/pipe. Failed vulcanising under ferrule.
First 2 inflations completed at 1000psi in a Ø96mm hole/pipe.

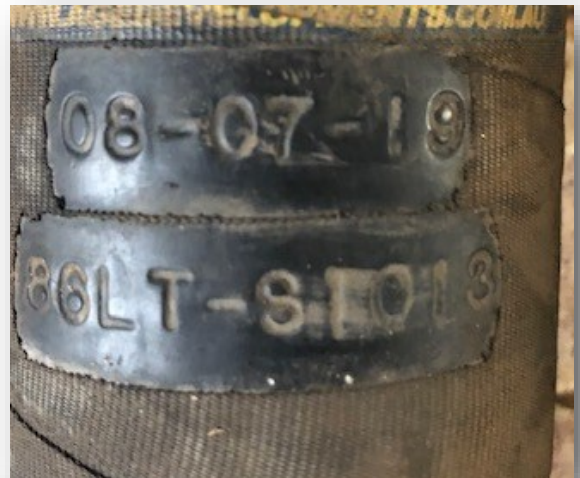
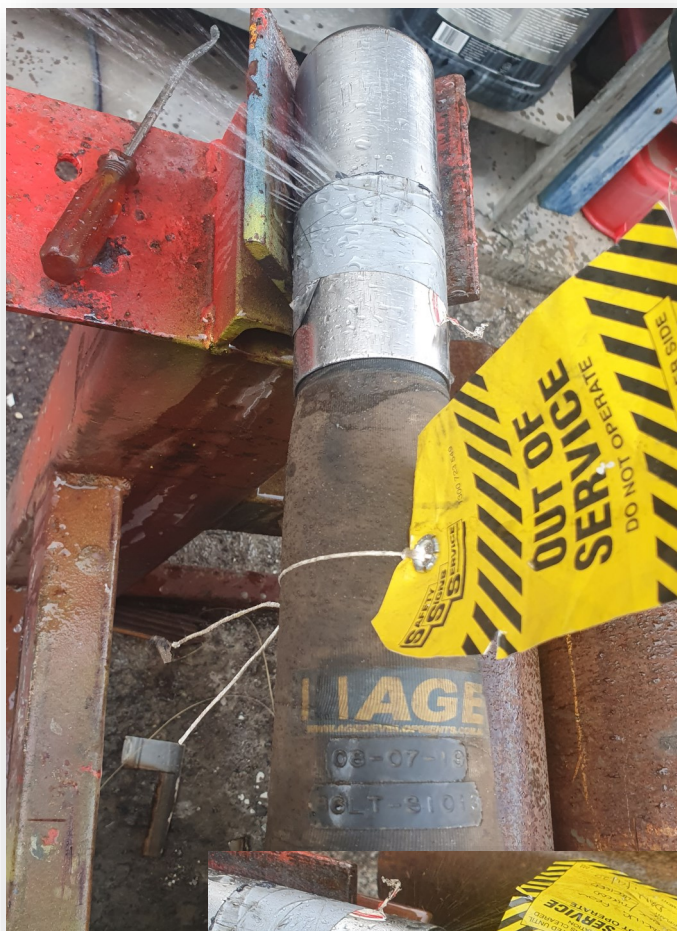
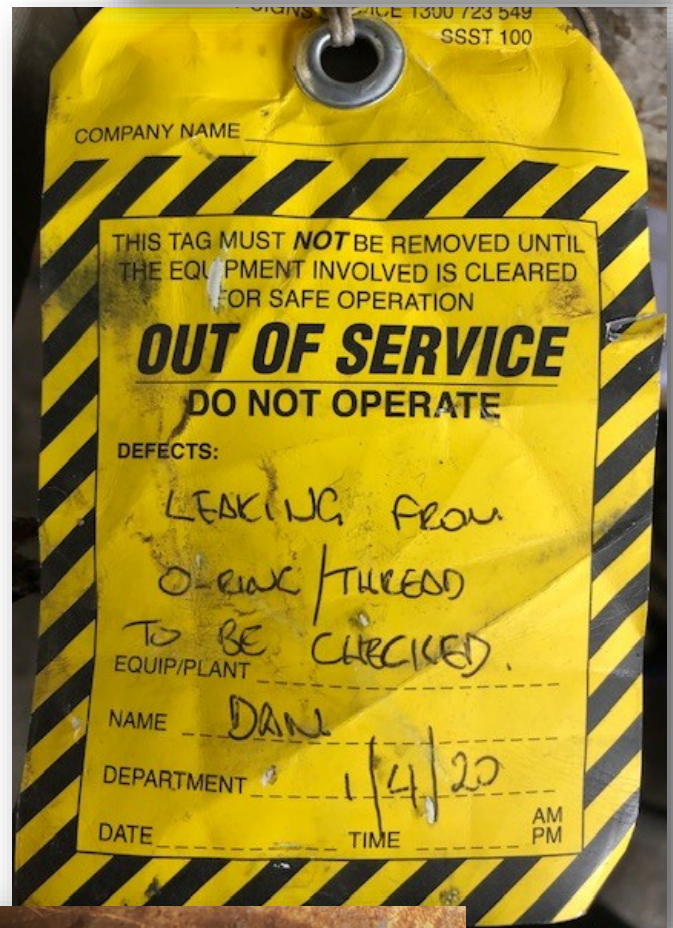
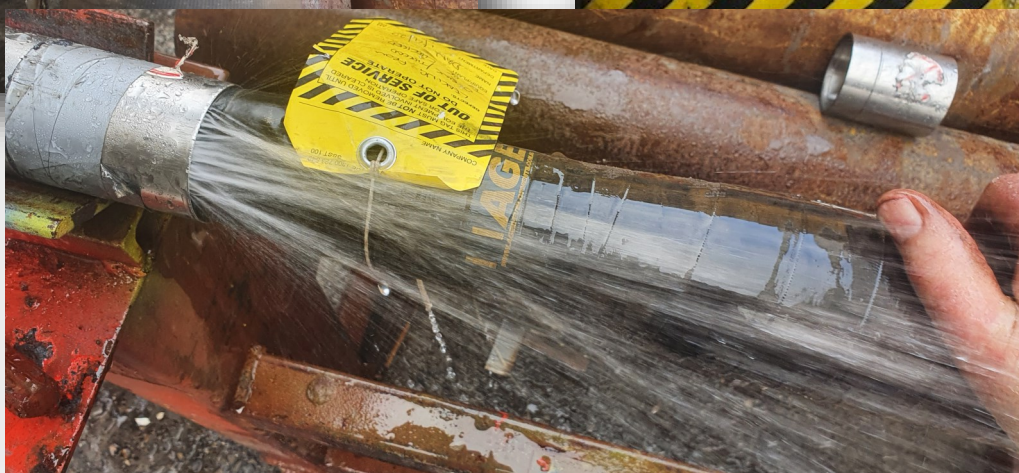
HQ PACKER Ø60 (86LT S1013 / 08-07-19)

Defects: Leaking from O Ring / Thread to be checked

Comments: Failed on initial inflation. Failed vulcanising under ferrule
