TEST REPORT

COMPETITORS PACKERS RETURNED TO RIPE FOR REBUILD

REPLACEMENT INFLATABLE PACKERS AND ELEMENTS PTY LTD

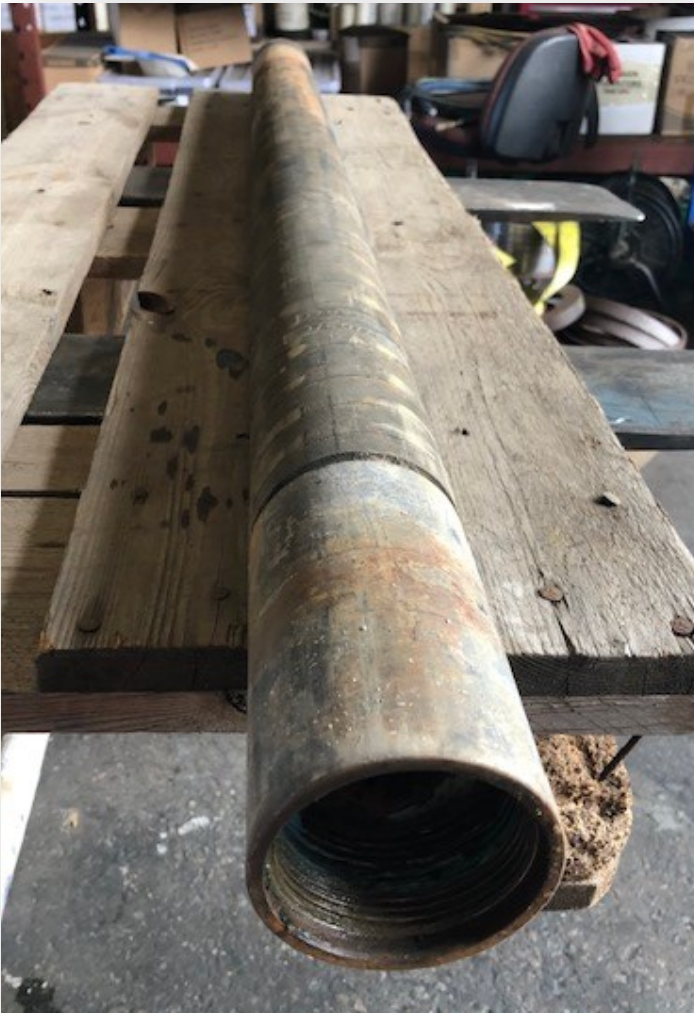
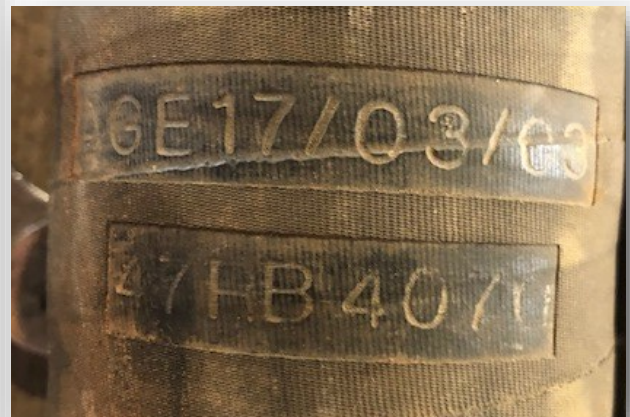
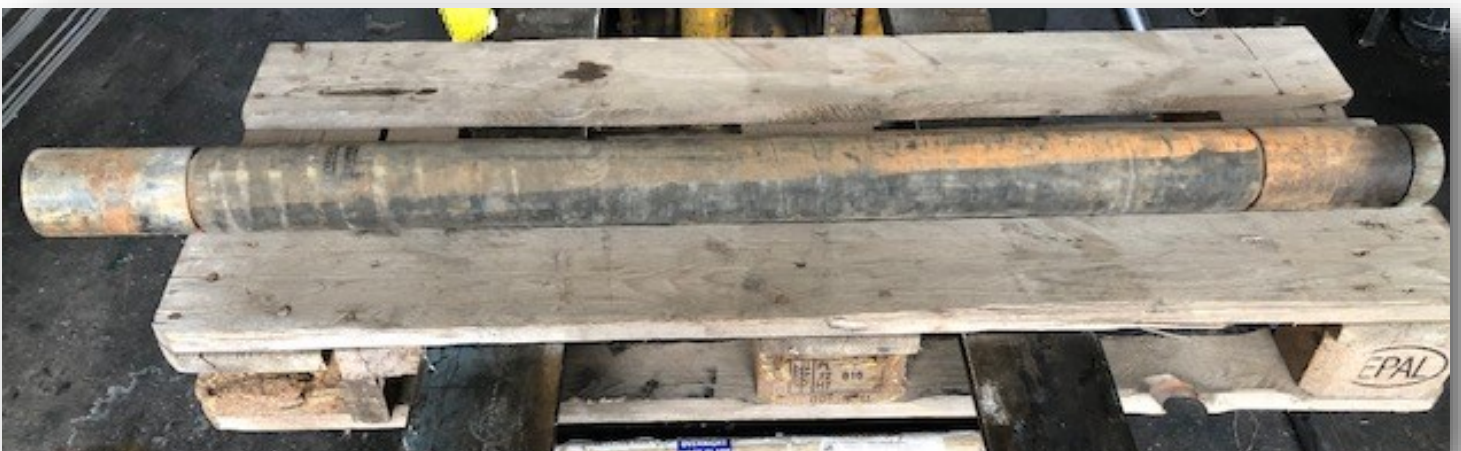
Ø80 SLIDING END - 7K PACKER (47RB4070 / 17-3-03)

OUT OF SERVICE TAG: No Tag

Embossing: 47RB4070 Date: AGE 17/03/03

Comments:
